# Current changes of sandy seashore of Lithuania within the impact of natural and anthropogenic processes

## Abstract

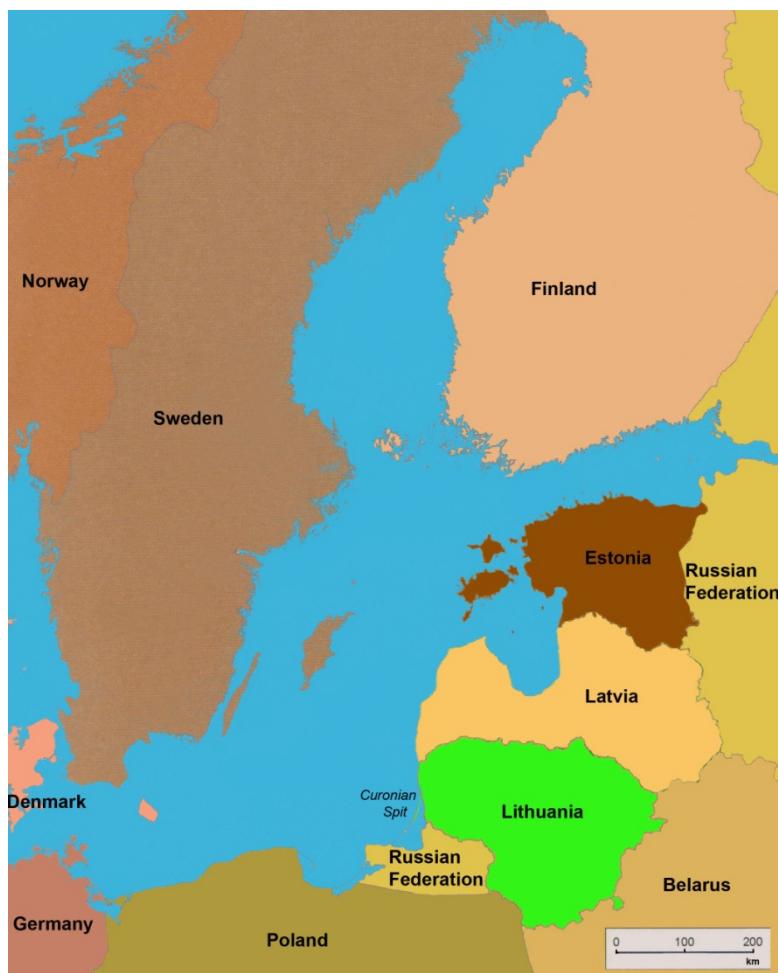
**Fig. 1.** Study area – Lithuanian seashore

The South-East coast of the Baltic Sea that borders the Lithuanian territory is mostly covered with sand (Fig. 1). Only within a short coastal strip (4,5 kilometers) of it, moraine cliffs are present. The coastal zone is open to storms, which are resulting into perfect fetch conditions for the development of waves. Therefore a constant care of the seacoast is of obvious necessity in order to save more or less stable coastline. During the last 25 years the mean sea level of the Baltic Sea near Klaipėda has risen by 10 cm and is still raising (Dubra & Grecevičius, 2006). Thus the abrasion of the seacoast might become much more active in future.

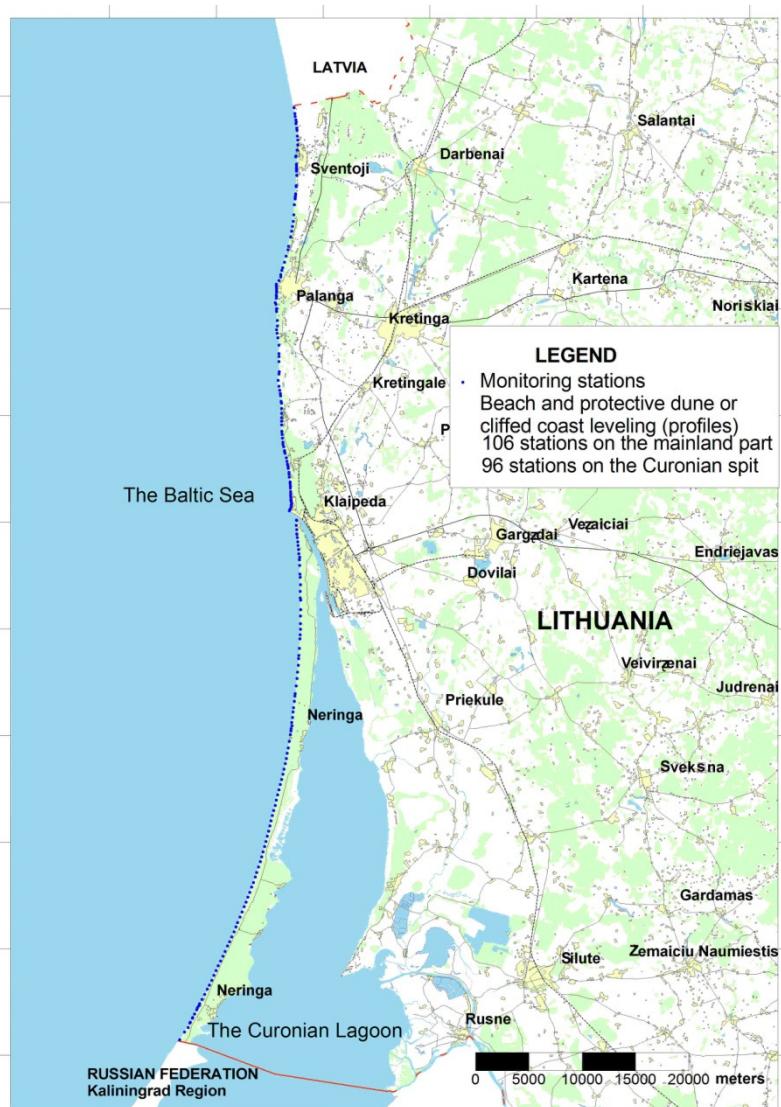
**Fig. 2.** Study area monitoring network

As we failed to find data of systematical seacoast investigations, everything had to be done from the beginning. Thus since 2000 a network of profiles was established instead of that episodic observations that had been made before. Every 200 meters were chosen in the areas frequently visited by people or destroyed places. In other places the survey was done every 500-1000 meters. Now the network is expanded by adding new temporal or permanent profiles in cases of new coastal abrasion occur. At present the monitoring of the coastal dynamics is performed in 129 profiles on the mainland part of the Baltic coast and in 108 ones on the seashore of the Curonian Spit (Fig. 2). Dune parameters are the subjects of geodetic observation methods. These include morphometric data accessed by the means of DGPS equipment and supported with WAAS/EGNOS functions and altimeter. More detailed observations and profiling are performed with the help of total geodetic station and tape-measures. Morphometric observations of the Baltic Sea coastal zone of Lithuania are performed by the authors of the paper twice a year in spring and autumn as well as after every extreme storm surge occasion. Yearbooks were the source for the collection of the historical data in order to extend data series. Historical data on the beach devastation rate originates from the monograph of V. Gudelis (1998). Experimental investigations from the Palanga promenade pier are performed in order to calculate sediment transport budget near the coast zone. Sea level readings are obtained by sea level gauge in Klaipeda. At least twice-a-day level data was put into statistical analysis.

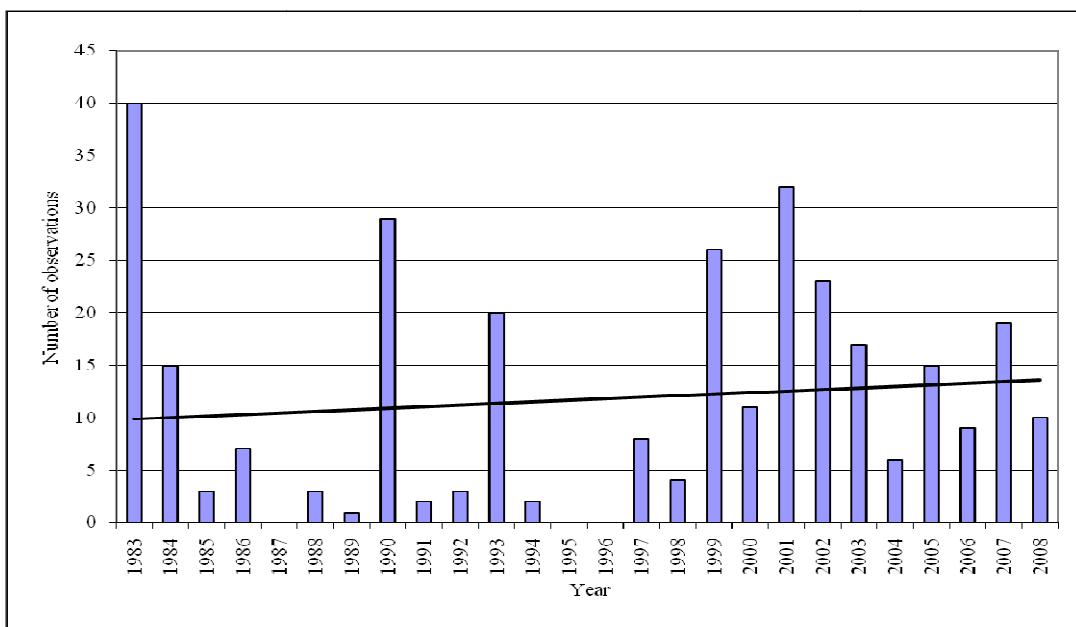
**Fig. 3.** Trendline of the annual number of three-hour wind observation cases with gales when the velocity exceeded 24 m/s at Klaipeda

During the previous decade the Lithuanian seashore suffered the worst stress on December 4, 1999 during the rage of the hurricane *Anatoly*. The shore was almost abraded. In the port of Klaipėda the second high (165 cm above zero, while the highest was 186 cm in 1967) sea level rise was recorded within the period of 200 years. January 8-9 in 2005 a bit weaker in strength and by 2.5 times shorter in duration strong storm *Gudrun* known also as *Erwin* occurred. During this hurricane the third high sea level rise was observed in Klaipėda. In 2002 January 29 the wind blew 32 m/s and the sea level raised up to 137 cm gauge (the eighth highest known sea level). Analogical storm broke in 2001 November 1, but the sea level was a bit lower (128 cm) at the time. In 2001-2002 from December till February there were 7 more cases when the wind speed in gusts exceeded 28 m/s. January in 2007 must be outlined too because the sea level exceeding 100 cm or close to it was registered as permanent for two weeks. This was the maximum such as duration since the beginning of observations. Recurrence of strong storms or hurricanes within the last decades is presented in Fig. 3, which shows the slight increase of stormy activities according to the annual number of three-hour wind observation cases when the velocity exceeded 24 m/s at the Lithuanian nearshore at Klaipeda

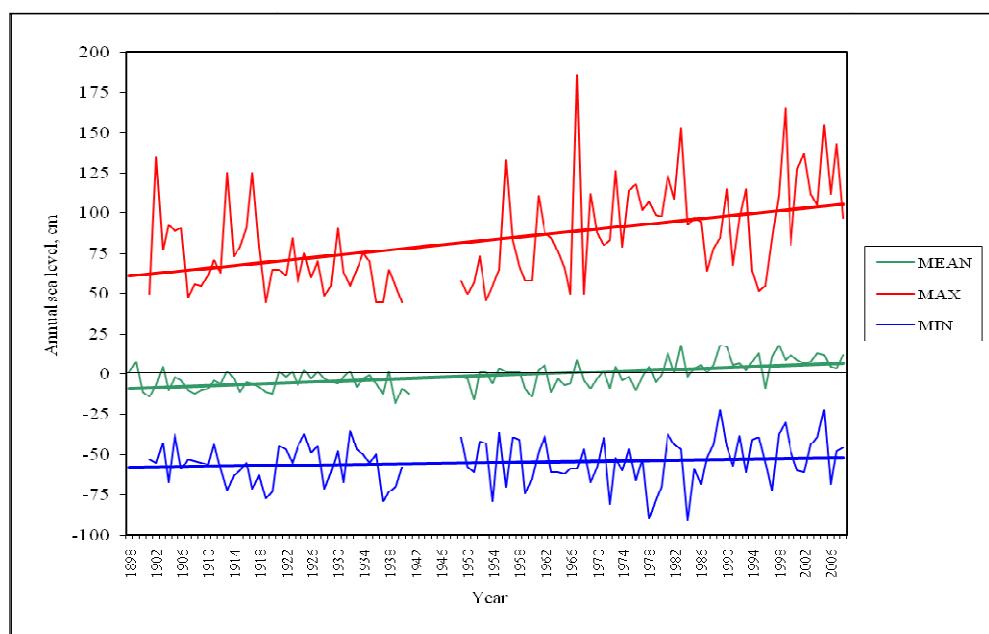
**Fig. 4.** Annual sea level trends in the Baltic Sea at Klaipeda.

During relatively mild winters frequent thaws exchanged with frosts occur which results in favourable conditions for suffosion processes on moraine coasts, which occupy 4.5 kilometers long strip of the seashore. When maximum annual sea level gauge readings are compared to minimum and mean data it clearly shows a constantly increasing trend. During the last 20 years it has been increasing extremely rapidly (Fig. 4).

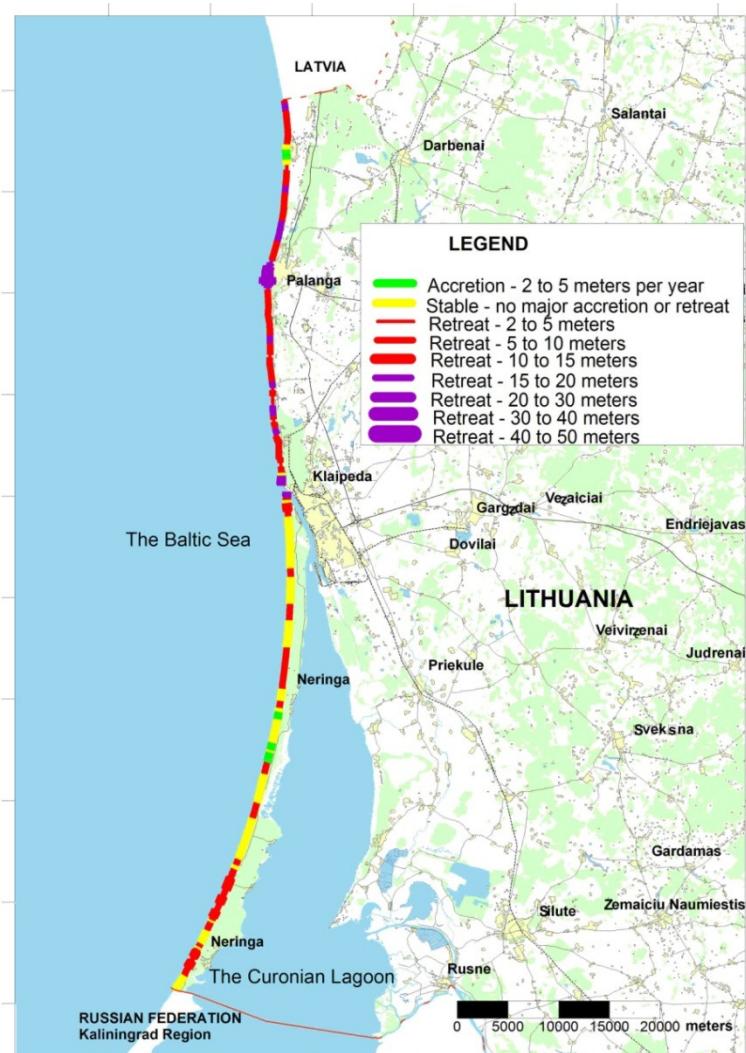
**Fig. 5.** Changes of the Lithuanian coast of the Baltic Sea in 1999-2009

During the hurricane *Anatoly* the mainland coast lost 30 hectares of the protective dune or the coastal slope. The worst damages were recorded near Palanga, where over 20 meters of the protective dune were swept away and the promenade pier was even separated from the land. Hydrotechnical constructions protected the dunes from damages near Klaipėda (mainland part) and Šventoji. During *Gudrun*, the seashore near Palanga again suffered the greatest loss (10 meters) in comparison to other places. Even the slopes covered with tree branches were swept away. During the strong storm the loss of the coast reached 7 hectares and almost 3 hectares were added by holiday makers, who destroyed plant cover, treaded paths and encouraged sand slides from steep slopes. In 2001-2002 during storms another 10 meters of the protective dune were swept away, and the sea shore lost 5.2 hectares. Even during 2003-2004, which were considered to be comparatively calm from the meteorological point of view, 2 hectares were lost. What is more, because of suffosion 1.5-2.5 meters of moraine shores are lost yearly. In the previous 6 years 41 meters of the protective dune were lost 1 kilometer southwards from Palanga. In 1999-2009 the continental part of the coast lost about 50 hectares of the protective dunes. It is only near border with Latvia where the foresters step by step are reconstructing the protective dune which was dug off when installing the oil terminal pipeline. In other places the dunes almost were not reconstructed. On the average 2 meters of the protective dune or the coastal slope are washed away during a year (Fig 5).

Mainland seashore endures great stress because of anthropogenic activities, too. During the period of exploration the protective dune that is 1 kilometer to the South from Palanga pier narrowed by 41 meters. Since pulling down of the groyne some 10-15 meters have been lost in addition. After arranging a stone bar (twice as short as the former groyne) in the middle of 2005 the situation improved to some extent, but the reliability of the stone bar will be verified by future hurricanes. Shore protection means are applied irregularly. Great amounts of stones, gravel and shingle are illegally taken out from the beaches for house building and other needs. Constant deterioration of the former port of Šventoji jetties can form a new area of abrasion in the nearest future. During the strong storm *Gudrun* water streams started flowing over the jetties. In future the present widest beach (120 meters) on the Lithuanian coast can become narrower. Great damages to Lithuanian sea coast are made during summer periods, when more and more dunes are trodden by their visitors and later by the winds. Average retreat rate of the protective dune for the Curonian Spit in 1859-1910 was about 60 cm (Fig. 6), but in 1999-2009 it occurred to be almost the same (referring to Fig. 5).

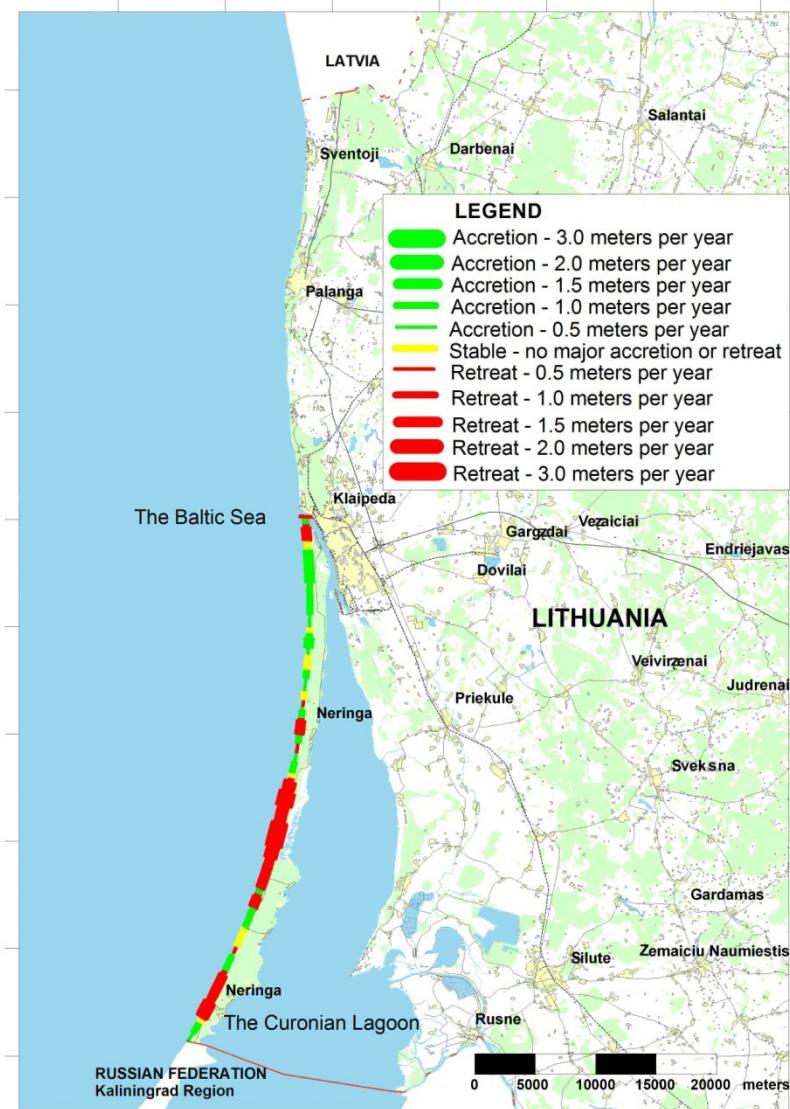
**Fig. 6** Trends of changes of the western slope of protective dune of the Curonian Spit in 1859-1910 (according to the historical data from Gudelis, 1999)
